**Group 1 - Joints Elimination in Heavy Haul Corridors –
A Study on Ferrovia do Aço and Serra do Mar Lines**

Aloísio Viana – MRS Logística S.A.

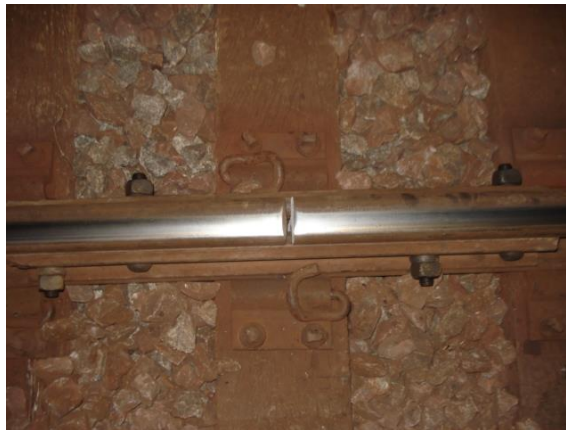
The joints can be placed "supported", that is, in this condition the faces of the rails are supported on a sleeper:

Figure 2 – Supported joint. Source: Authors

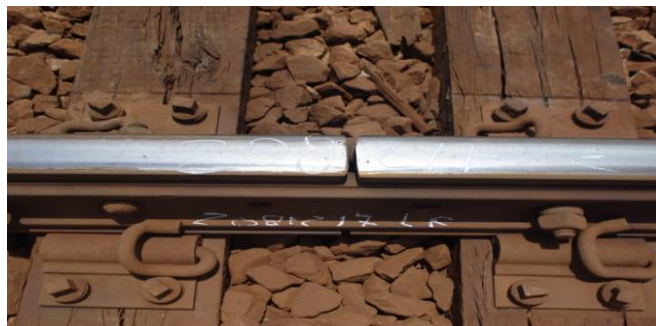
They can also be placed on a scale, that is, the faces of the rails are suspended between two sleepers:

Figure 3 – Hanging/ in-balance rail Joint. Source: Authors

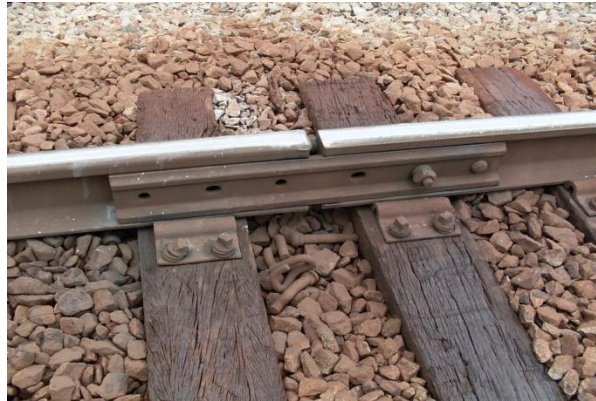
The major risk involved with this anomaly is the misalignment of the rails vertically or horizontally. The impact of a rail flange with the face of a rail can cause a derailment

Figure 6 – Unconnected joint. Source: Authors

This type of anomaly is characterized by the breaking of all the screws of one of the rails that is tied up to the metal joint. These bolts are broken due to several factors:

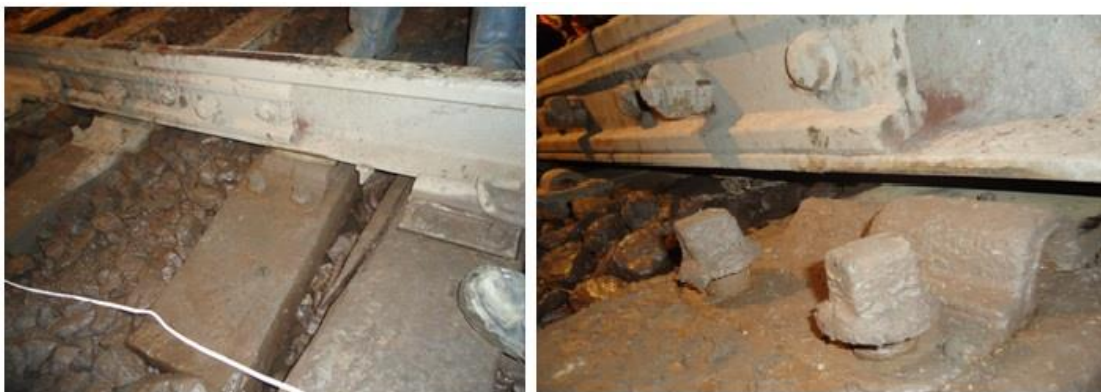
When the wheel / rail impact forces are transferred to the ballast, they cause the friction between the stones what cause them to deform and generate fines, which results in the loss of the drainage characteristics of the ballast at this location. Thus, during the rains, the water is dammed in the ballast, causing great loss of leveling of the track in this specific point.

The main risk of this type of anomaly is the appearance of geometric defects such as twists or torsion, which could cause a derailment by the relief of wheel at the point of the unevenness.

Figure 7 – Ballast Pocket. Source: Authors

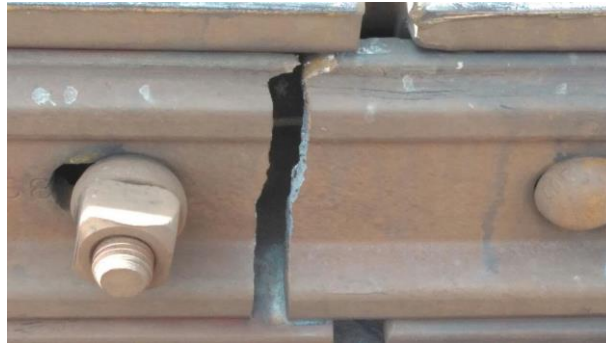
Due to the constant impacts and the characteristic unevenness in these components, there is a natural process of fatigue of the joint and consequently break. This type of anomaly is one of the most dangerous in the railway due to its characteristic of discontinuity, similar to a broken rail. However, the identification is more difficult, since generally the fracture of the joint does not generate occupation

This type of anomaly can culminate in a mismatching of the faces of the joint rails and, consequently, in a derailment.

Figure 8 – Broken joint. Source: Authors

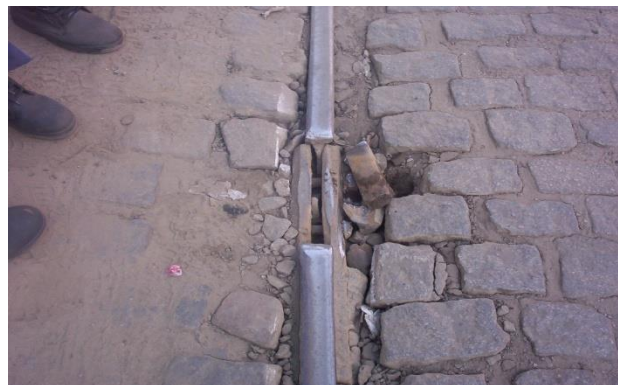
The excessive effort that the joints have plus the degradation of the other components of the railway superstructure, can cause an accelerated propagation of internal rail cracks, culminating in a top rail crack.

This type of anomaly is also characterized by the discontinuity of the track, and has the aggravating effect of not generating occupancy of the track circuit, because of the joint bonding.

Figure 9 – Vertical Cracks on the Rail – (top rail crack). Source: Authors

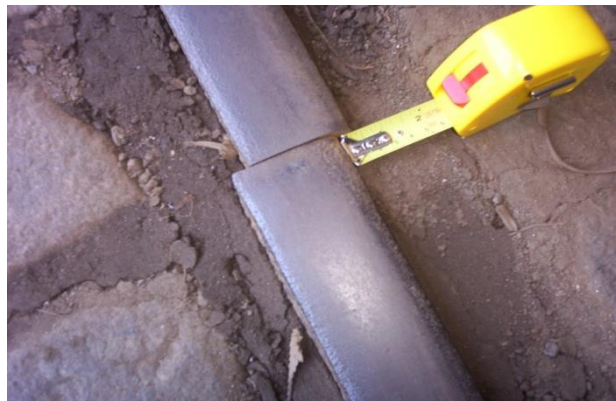
The tightening of the bolts on the splints in a joint is fundamental to ensure uniformity in the gauge line of the rails. If the bolts are improperly torqued, it may result in mismatching of the rails on the gauge line. This type of anomaly can cause a derailment if there is an impact of the wheel flange with the face of one of the rails.

Figure 11 – Rail Misalignment at Gauge Line. Source: Authors

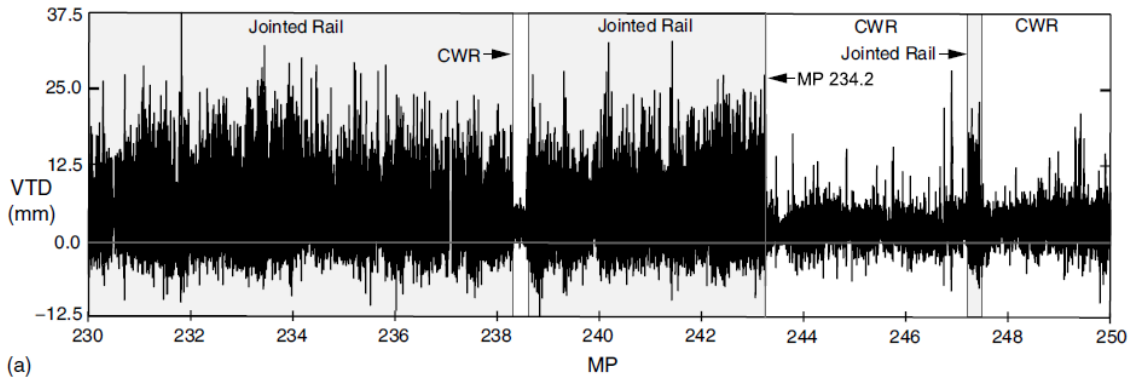
The following graph shows unprocessed vertical track deflections data recorded on one side of the rail over a 32 km long section of the Canadian National’s (CN) Lac la Biche Subdivision. This section of track contains both continuously welded and bolted rail segments. It is possible to identify a clear difference between measurements taken on track with continuous welded rail (CWR) versus jointed rail.

(a) Figure 14– Vertical track deflection graph. Source: Continuous Vertical Track Deflection Measurements to Map Subgrade Condition along a Railway Line: Methodology and Case Studies Alireza Roghani and Michael T. Hendry, Ph.D., P.Eng.2

Examining the Vertical Track Deflection graphs, we observe that in subsections with joints the deflection is considerably larger when compared to the CWR section.

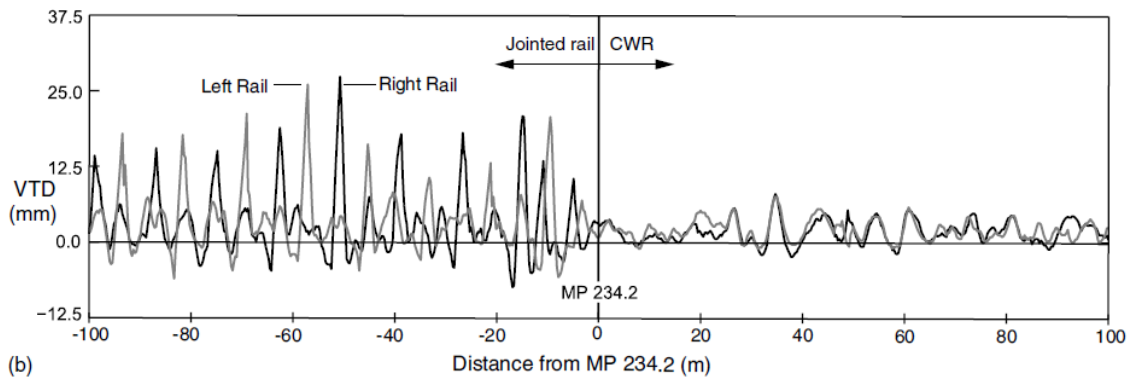
The next graph shows the variation of the measurements on both sides of the rail over a 200 m subsection of this track. Peaks in the values that occur at a relatively constant 12 m interval on each side of the rail correspond to the space between joints in the track; the negative values measured after the large peaks correspond to the joints. From the configuration of the system, a negative vertical track deflections value implies that the rail is rising above its original position.

(b) Figure 15 – Vertical track deflection graph (subsection). Source: Continuous Vertical Track Deflection Measurements to Map Subgrade Condition along a Railway Line: Methodology and Case Studies Alireza Roghani and Michael T. Hendry, Ph.D., P.Eng.2

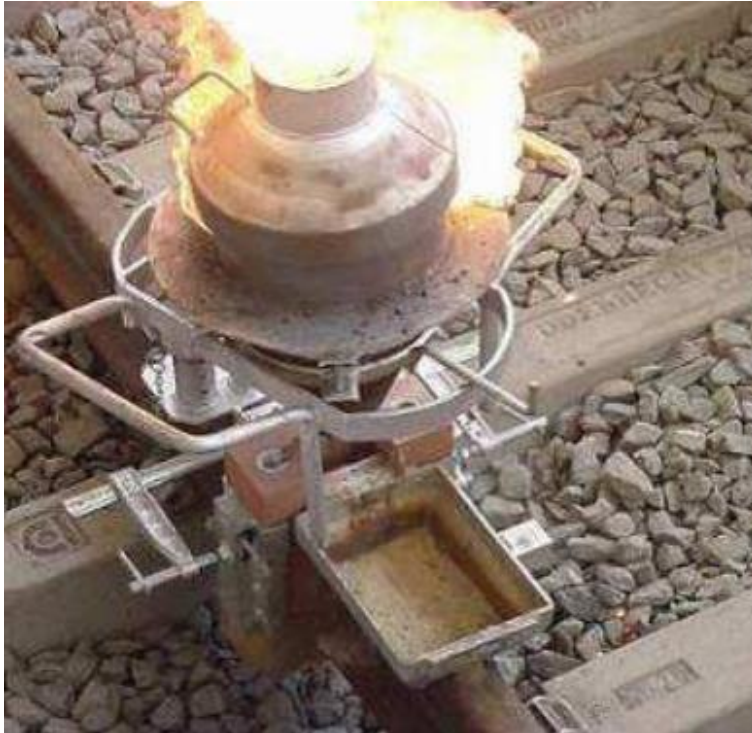
- ✓ Alignment of the rail ends;
- ✓ Installation of half-molds for welding;
- ✓ Quartz sand;
- ✓ Bring the crucible into the welding position;
- ✓ Initiation of the implementation (ignition bar);
- ✓ Inflow of the mass in the molds;
- ✓ Machining of the weld;
- ✓ Rough grinding on the weld;
- ✓ Cleaning of the weld.

Figure 18 – Aluminothermic Welding. Source: MRS Logística

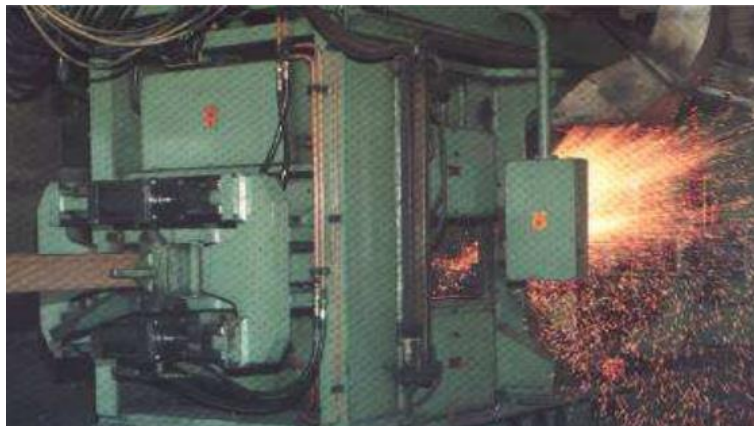
Figure 19 – Machine on welding yard. Source VIDON 2006.

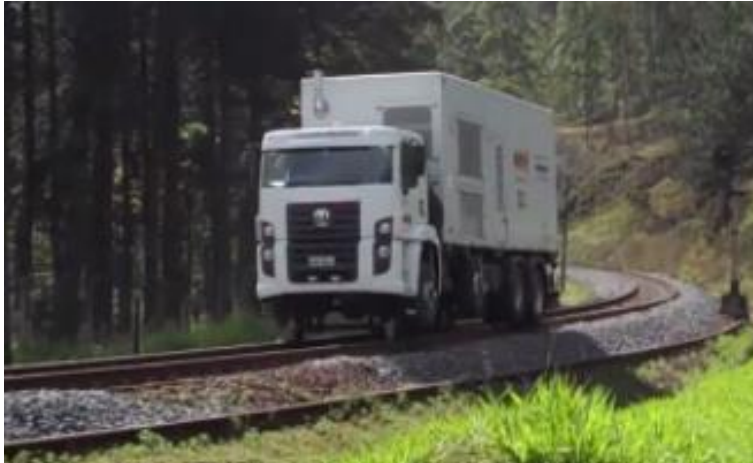
Figure 20 – Flash butt machine. Source: MRS Logistica

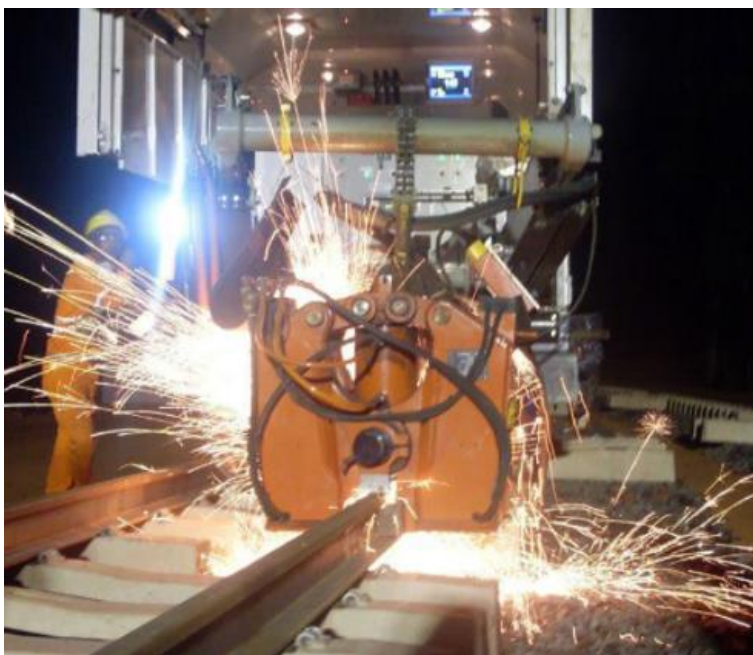
Figure 21 – Flash butt machine in action. Source: MRS Logistica

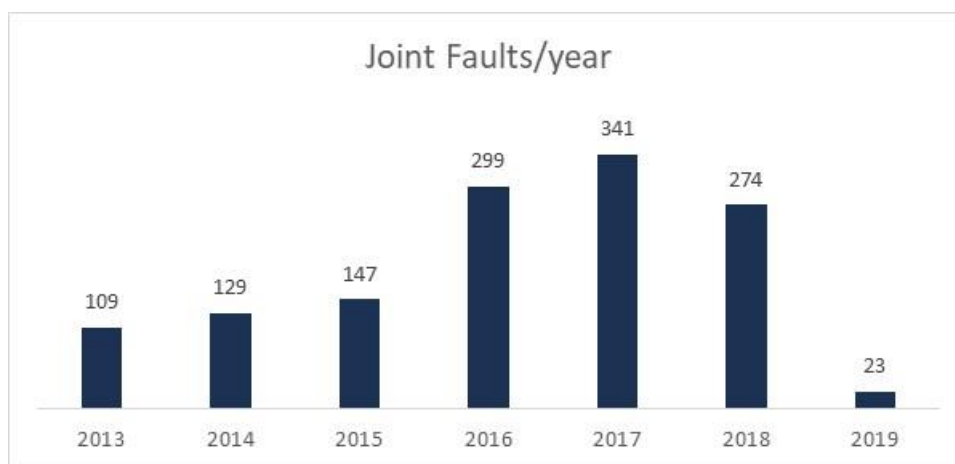
Figure 28 – Joint Faults Count throughout the Entire Rail Network (Figures are higher since 2016 due to a change in sort methodology and a more solid recording). Source: Authors

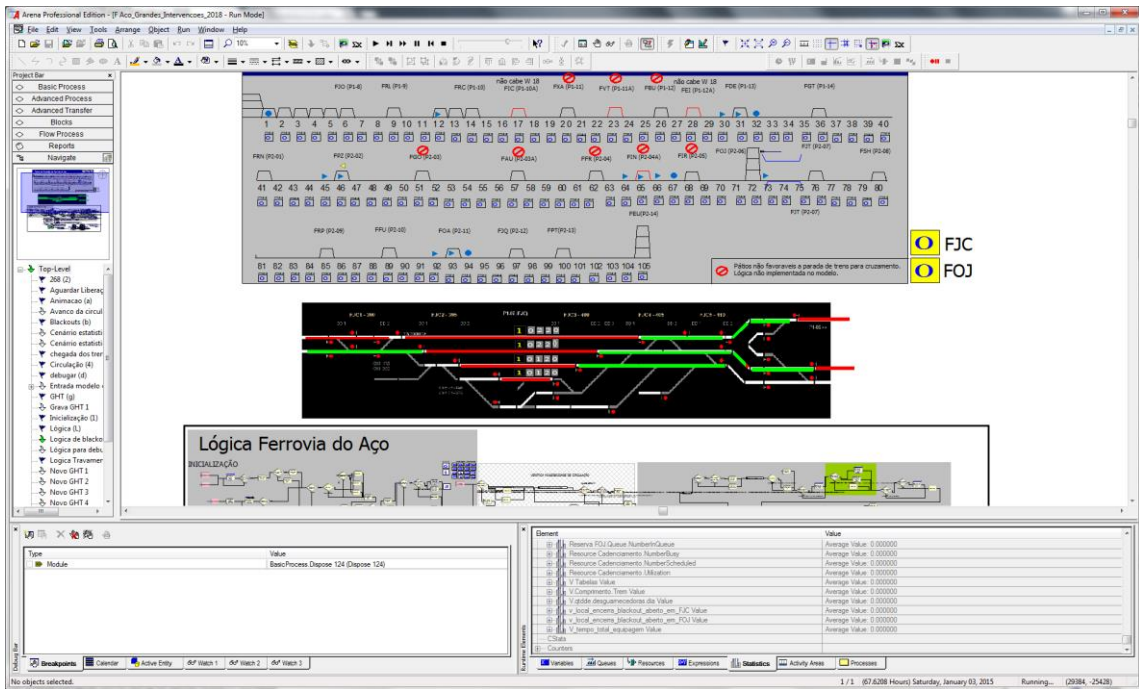
Figure 31 – Ferrovias do Aço Model Screen. Source: Authors

Figure 29 – Joint Faults Count – Per Track Maintenance Supervision. Source: Authors..	23
Figure 30 – Estimated Probability Distribution - MTBF for Ferrovia do Aço. Source: Authors.....	24
Figure 31 – Ferrovia do Aço Model Screen. Source: Authors	25
Figure 32 – Operational Impacts in Ferrovia do Aço. Source: Authors.....	25
Figure 33 – Operational Impacts in Saudade-Brisamar. Source: Authors	26
Figure 34 – Rail Accident in Volta Redonda. Source: MRS Logística S.A.	27
Figure 35 – Time x Distance Plot of Ferrovia do Aço. Source: MRS Logística S.A	29
Figure 36 – Spatial Distribution of Metal Joints. Source: Authors.....	30

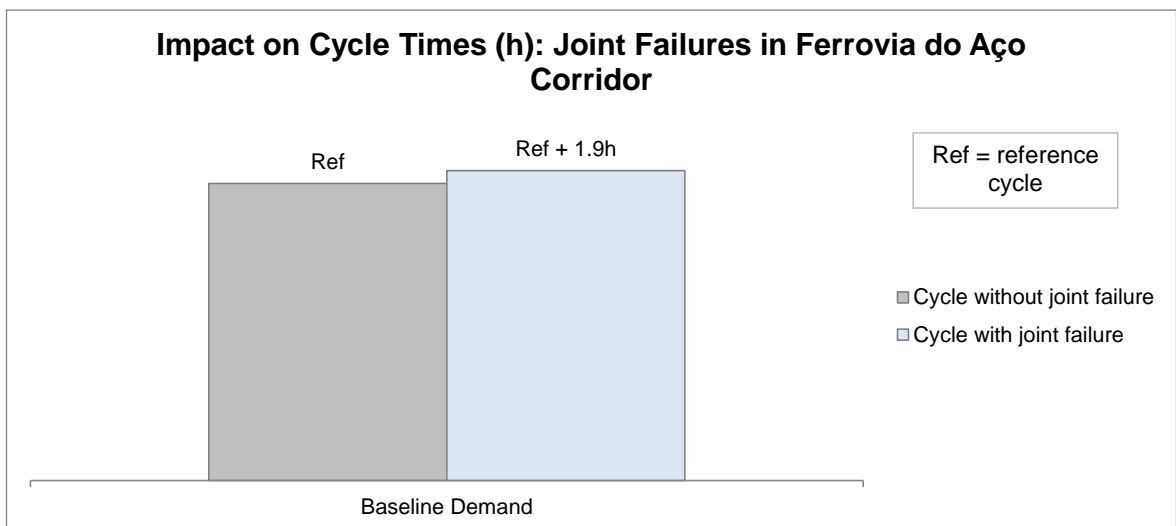
Figure 32 – Operational Impacts in Ferrovias do Aço. Source: Authors

It was expected that in Saudade-Brisamar, the impacts were not be statistically significant, since it is made up by double track, and the mean time of interruption was not high. On the other hand, in Ferrovia do Aço, MTTR was regarded as 7 hours and for a single line network, even featuring sidings, the impact cause the cycle times to increase approximately 2 hours. In terms of capacity it is not a constraint, since the company has train sets to cope with cycle augment. But is reduces profit margin, whereas operational costs increase, leading up to more fuel consumption, work time of train driver (engineer) and other small losses on a daily basis.

Basically, in Ferrovia do Aço, throughout the year, 36.5 hours were computed as train delays regarding joint failures. In comparison, the simulation run appointed an average increase of 2 hours for each train, since all failures were taken as traffic disruptions. Thus, for this corridor, the real impact can be deemed as much lesser.

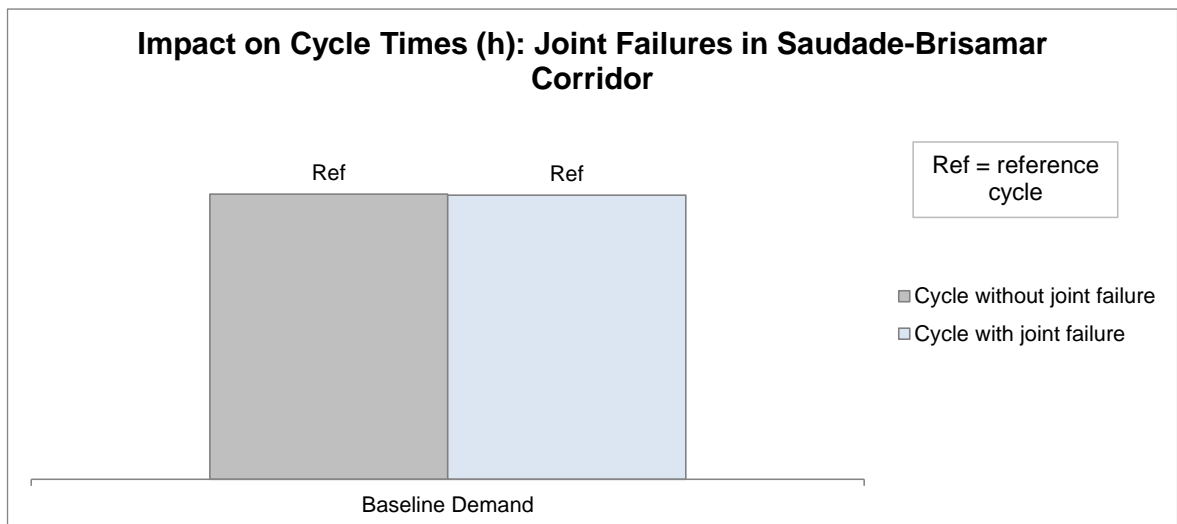
Figure 33 – Operational Impacts in Saudade-Brisamar. Source: Authors

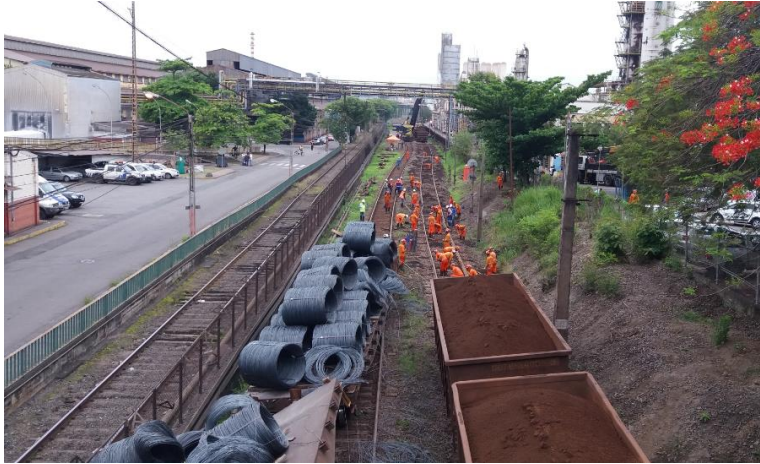
In November of 2017, a train derailment seriously damaged a viaduct in Volta Redonda. After weeks of investigation, it was found out that a loose joint was the main cause of the accident. Somehow, due to a failure in following track inspection procedures, the joint had no screws holding it.

Figure 34 – Rail Accident in Volta Redonda. Source: MRS Logistica S.A.

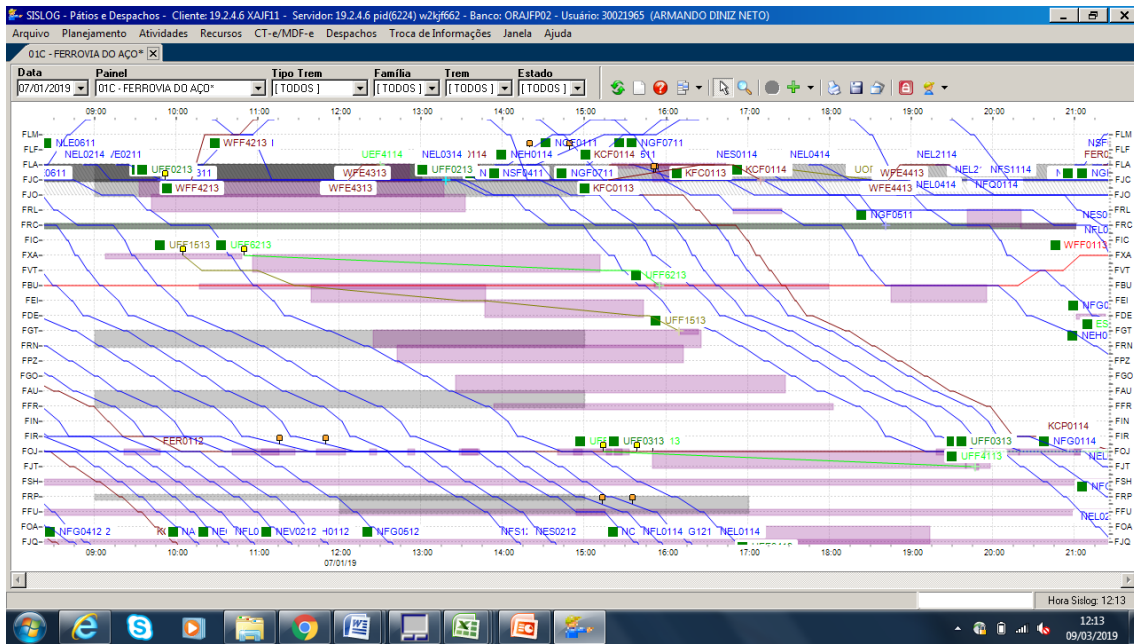
- ✓ **Ferrovía do Aço** – 4 hours of possession in nearly all the corridor in 2 days a week.

Figure 35 – Time x Distance Plot of Ferrovia do Aço. Source: MRS Logística S.A
